TRANSIT
AUTO PARTS

NON-WARRANTY ROTOR DIAGNOSTIC CHART

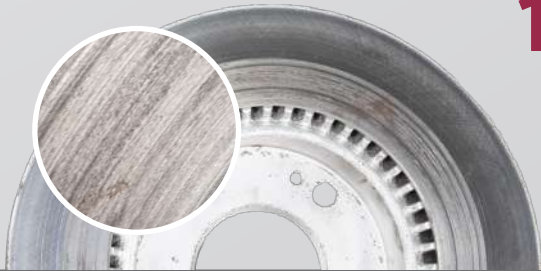
1 Previous pads reused

Pads were not replaced with rotors causing transfer of scratch pattern on the new rotors.

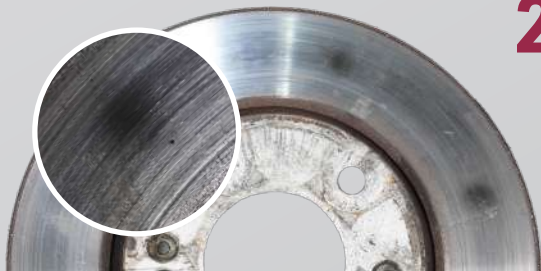
2 Poorly cleaned bearing hub surface

O-shaped deposits on rotors caused by irregular surface area from bearing hub pressure.

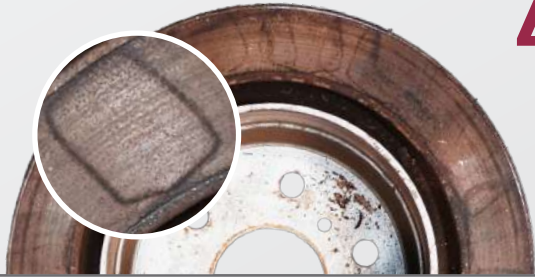
4 Poorly cleaned or lubricated brake components (caliper parts)

The pads want to stick to the rotors, you can see the imprint on the surface. This causes overheating and material build-up that will cause pulsation when braking.

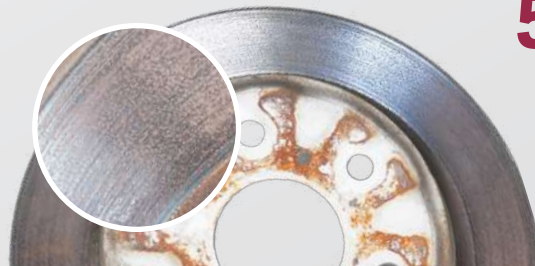
5 Surface corrosion (deposit)

Vehicles have not been driven.

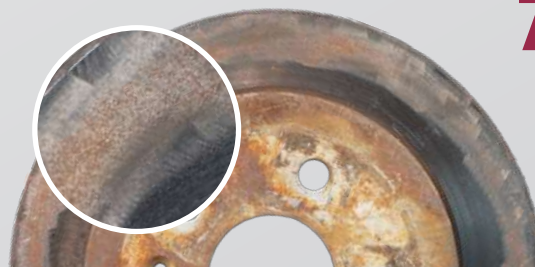
7 Altered Disc

Rotor has been altered with a sanding disc or grinder etc.
